Maryland Historical Trust

Maryland Inventory of Historic Properties number: CE-1475

Name: Bazor Strap Rd over Storey Run

Maryland Historic Highway Bridges
Bridge Type Metal Girder
Map B-15
County Cecil
Bridge # and name CE 72/Razor Strap
Rd. over Stoney Run

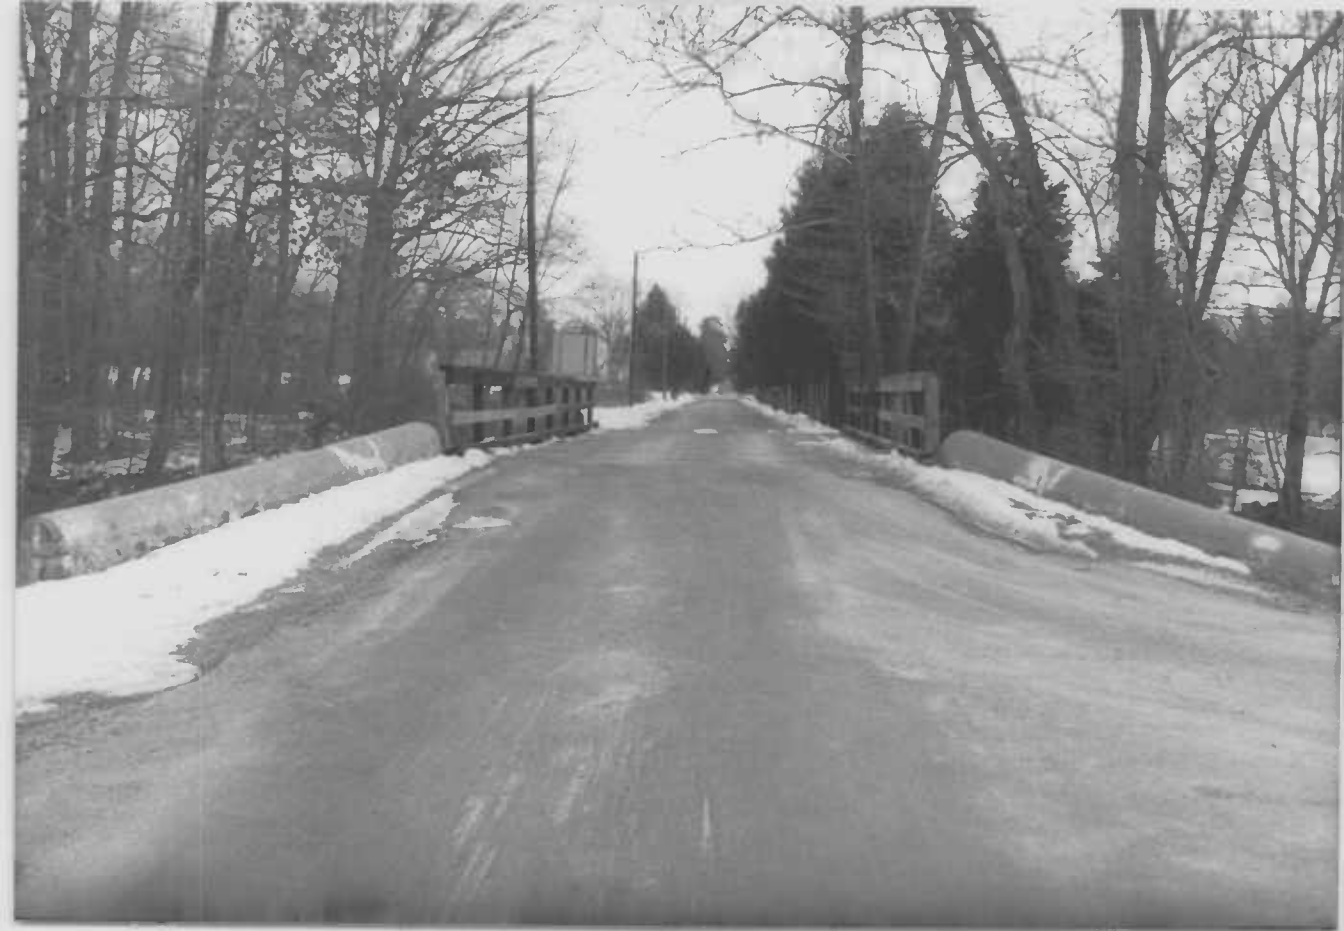
1 OF 5

LOOKING EAST

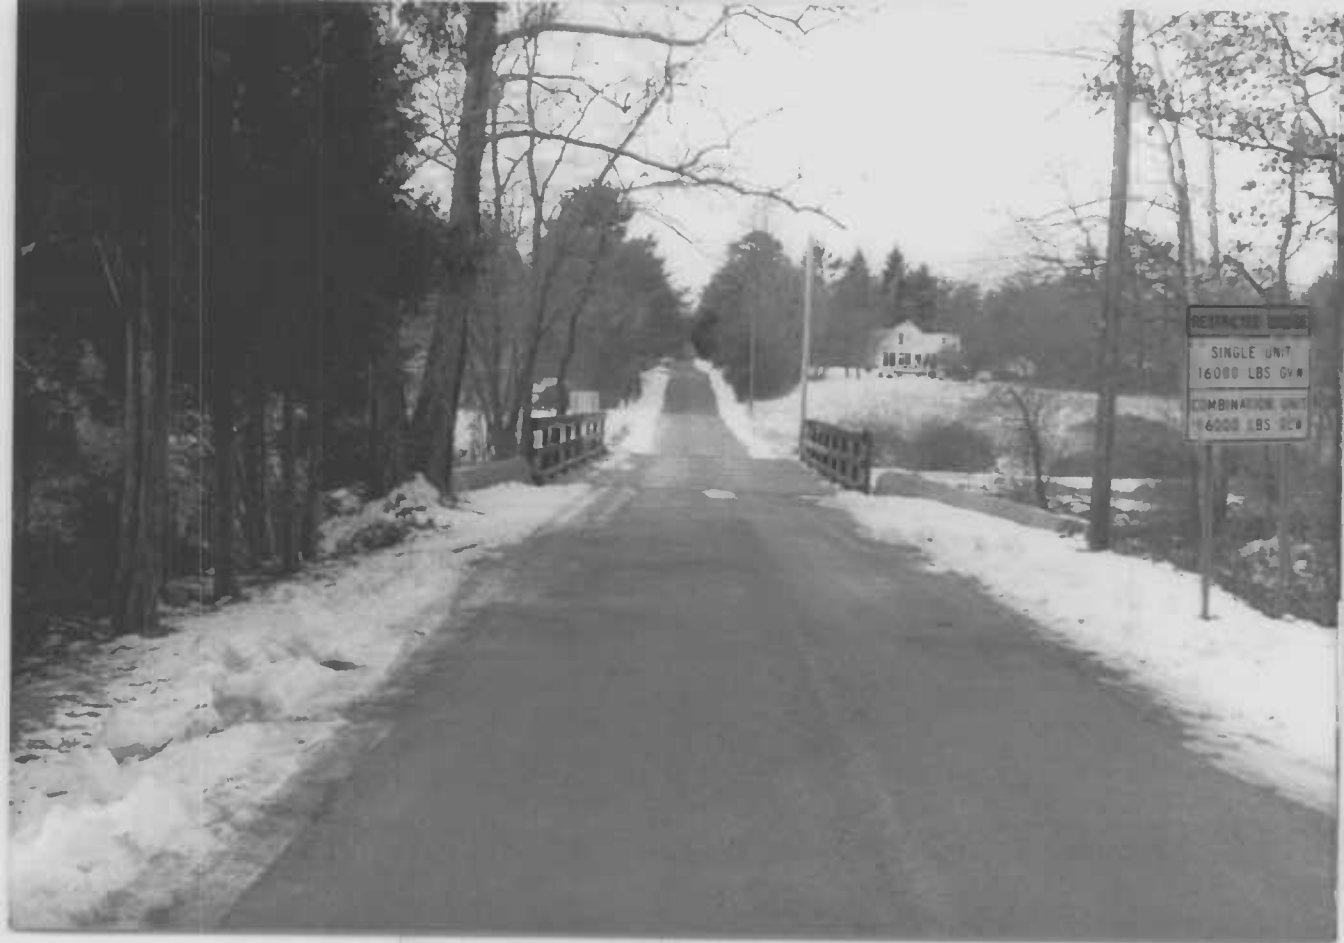
2 OF 5

RESTRICTED WEIGHTS

SINGLE UNIT
16000 LBS GVW

COMBINATION UNIT
6000 LBS GCW

LOOKING WEST

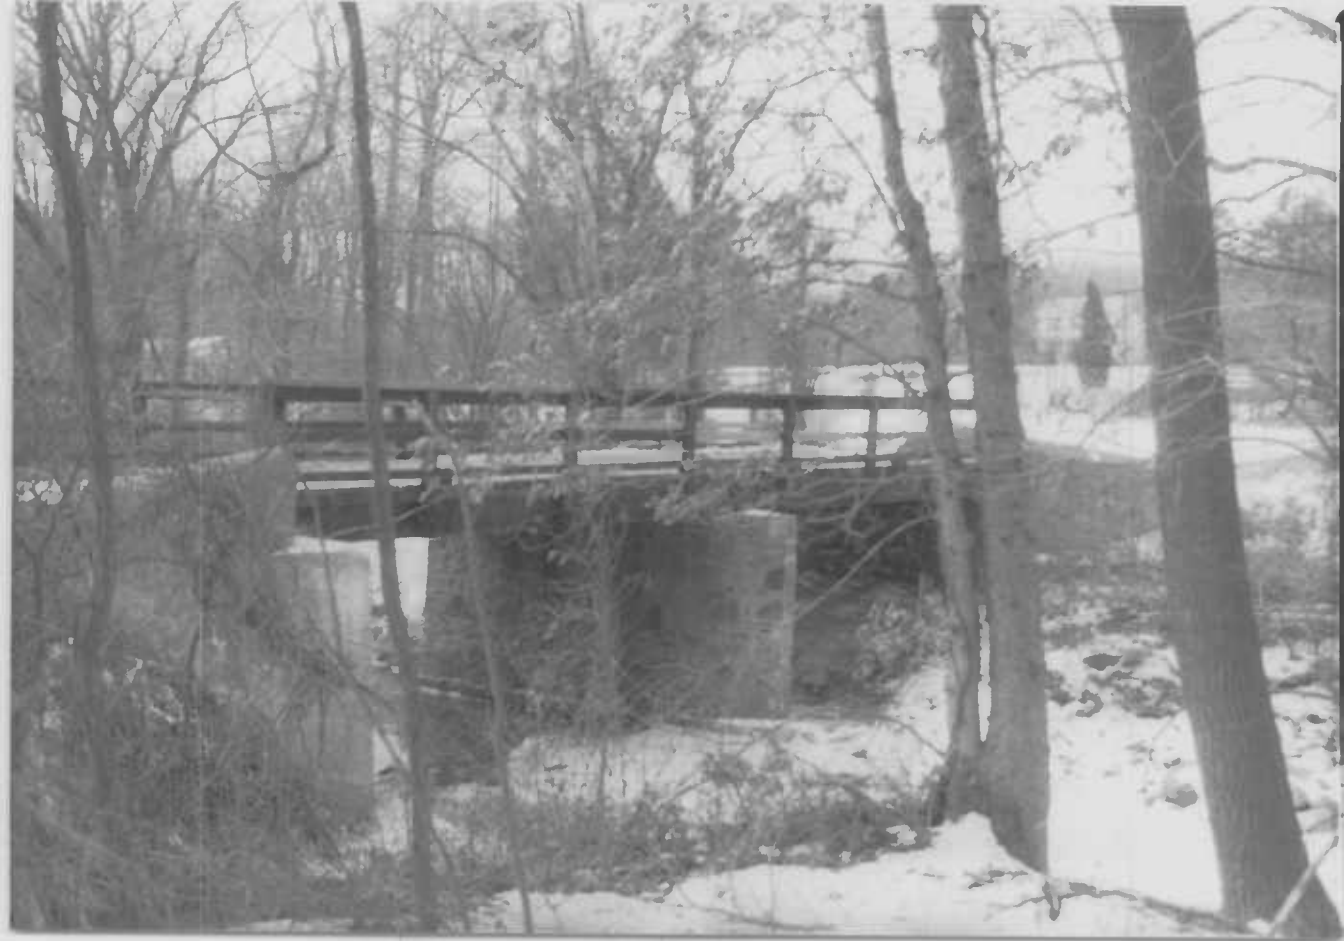
3 OF 5

UPSTREAM SIDE OF BRIDGE

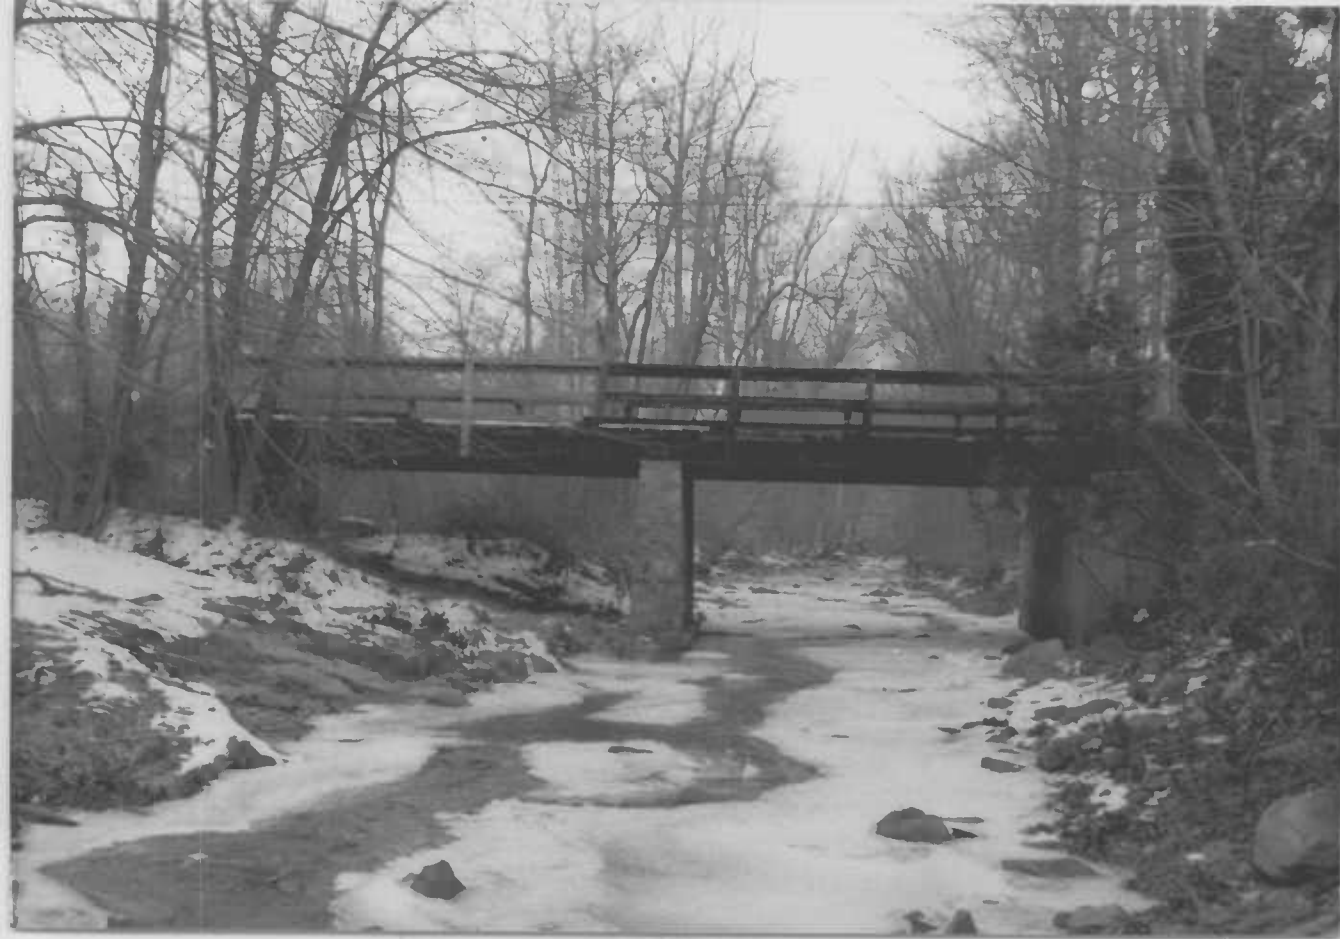
4 OF 5

LOOKING UPSTREAM

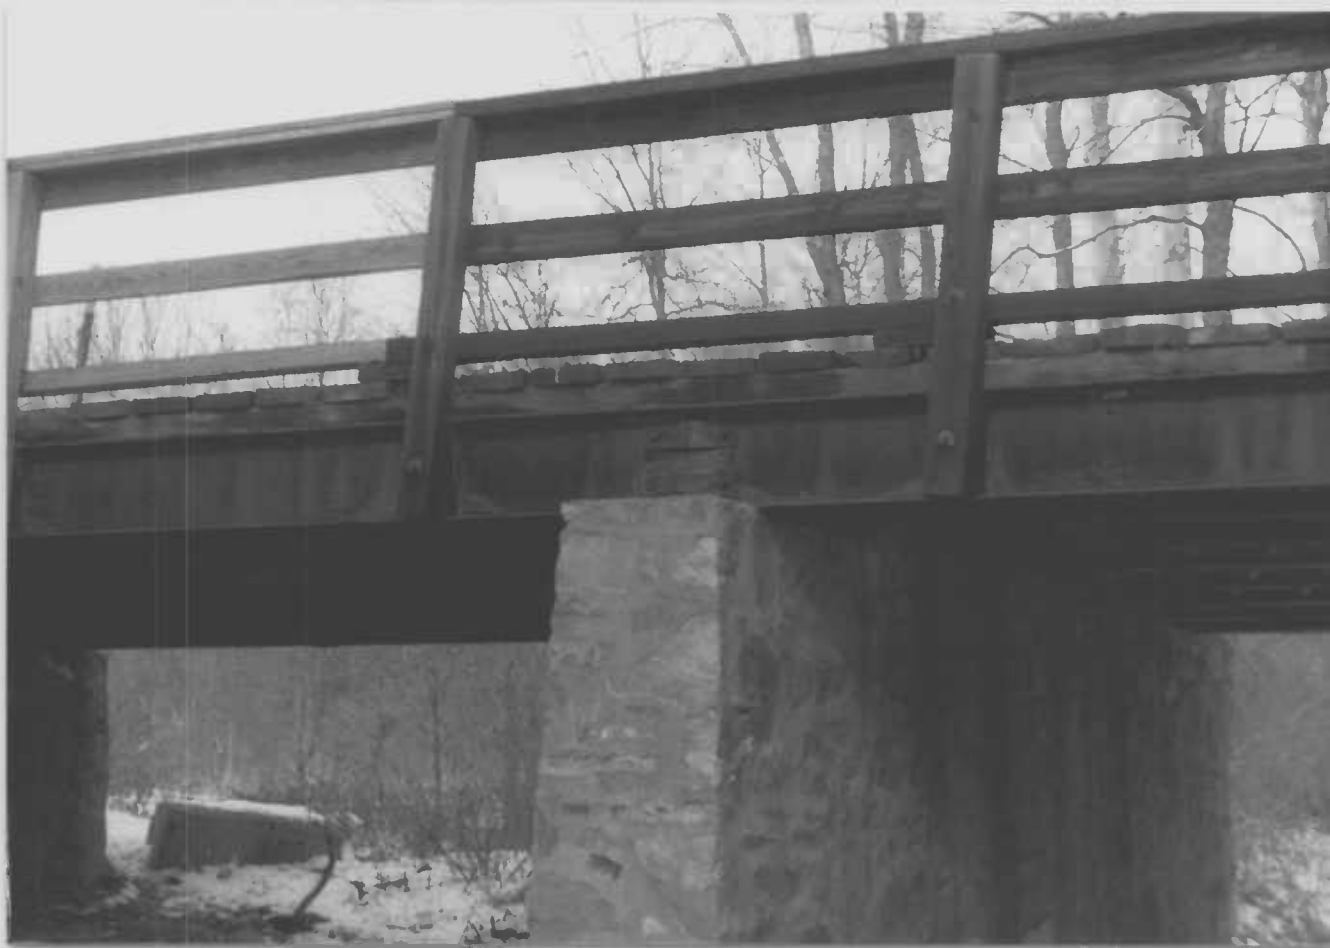
5 OF 5

Bridge CE 72 is a two span simply supported steel stringer bridge with a timber plank deck, built in 1930. The bridge is 52' long and 17' wide from curb-to-curb. Abutment A and its wingwalls are full height masonry, while abutment B is full height concrete with masonry wingwalls. The single pier is masonry. A splice of one of the exterior beams is visible directly above the pier.

BEAM "SPICE" @ PIER
